2019 Lavaca Basin Highlights Clean Rivers Program Report

*Prepared by the
Lavaca-Navidad River Authority (LNRA)
PO Box 429, Edna, TX 77957*

LAVACA BASIN HIGHLIGHTS REPORT 2019

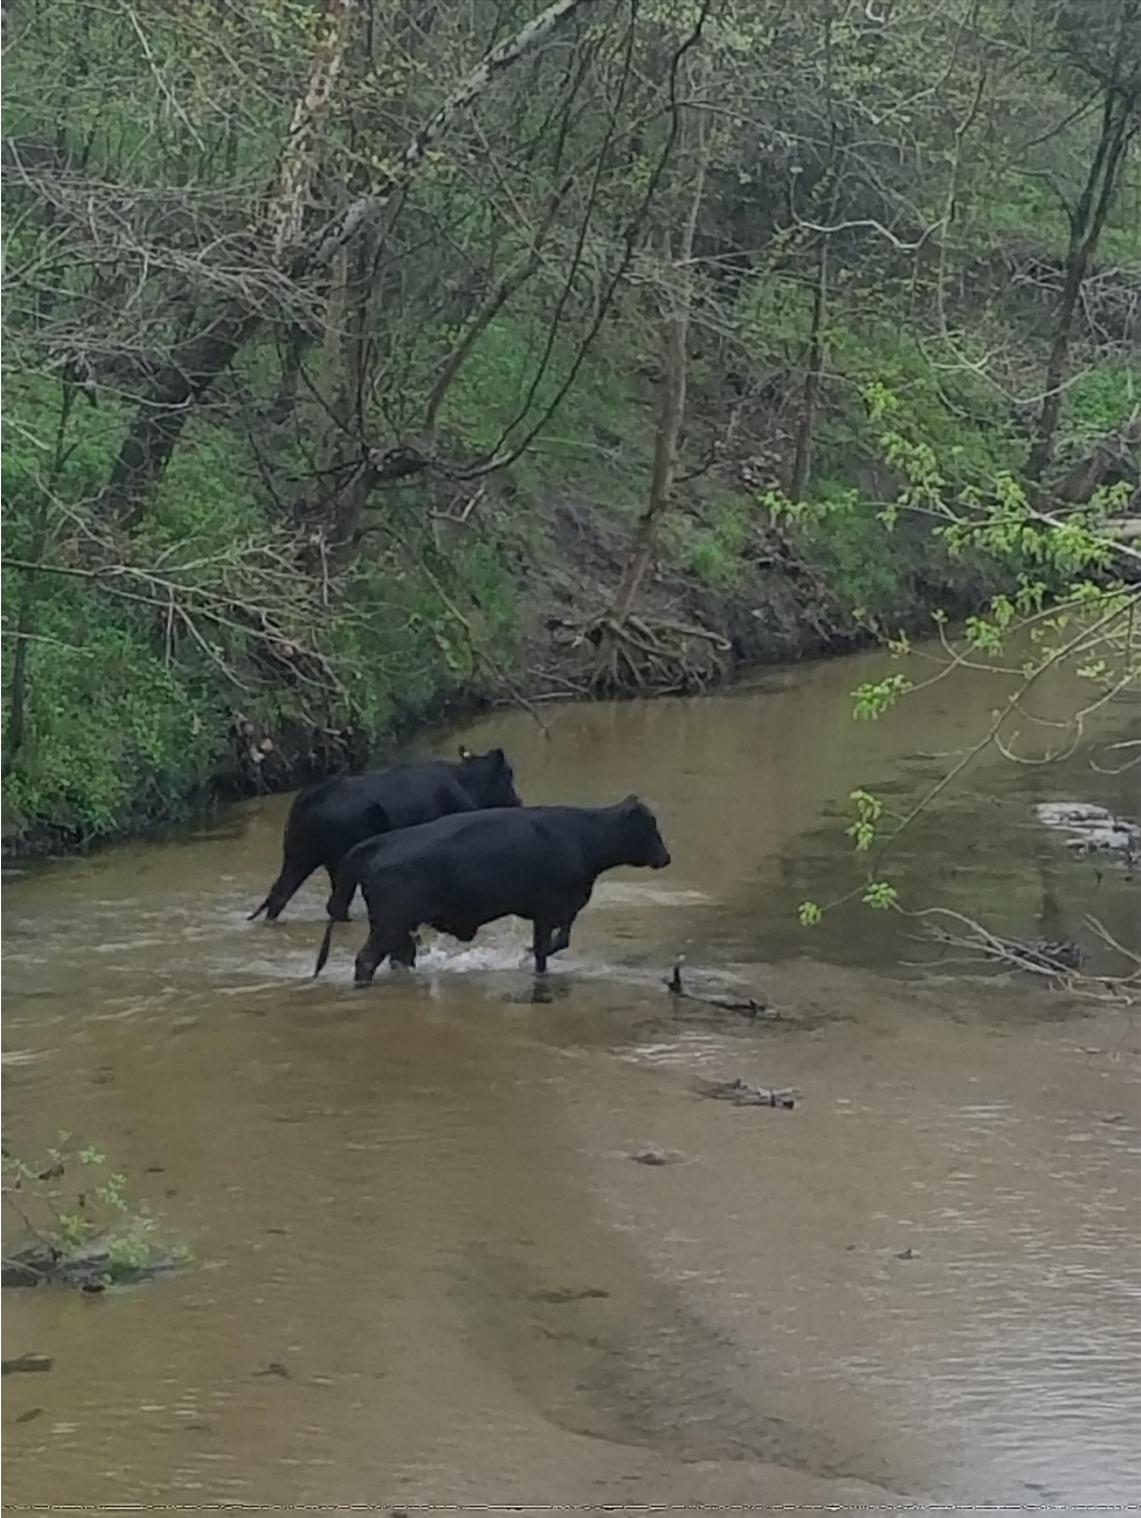
Figure 2: Livestock in Rocky Creek downstream of LNRA sample site

There are a variety of contributing factors to elevated bacteria levels within the stream including livestock, wildlife, an onsite sewage facility, and stormwater runoff. In order to meet the goals outlined in the WPP it will take approximately 10 years to reduce bacteria levels below criteria. To better target potential sources of bacteria, TWRI has contracted with LNRA to sample four (4) sites monthly for twenty-four (24) months targeting areas of interest within the River with higher levels of *E. coli*. Overall, the plan sets goals to improve the water quality of the streams and allow stakeholders to rely on the resource for their livelihoods.

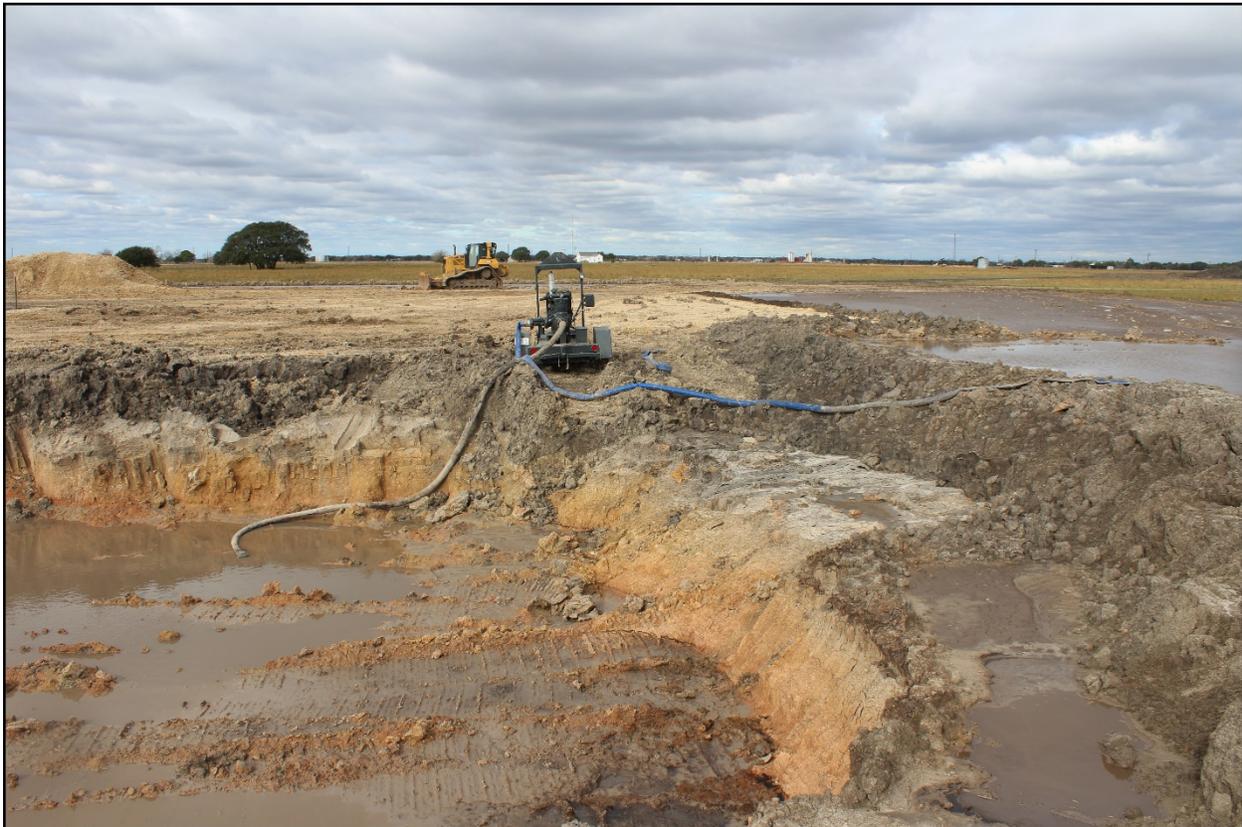
Figure 3: Sludge being pumped from oil field sludge pit

On Friday December 14, 2018 the Lavaca-Navidad River Authority was contacted regarding a potential oil spill. The location of the spill was southwest of the City of Ganado along FM 2982 and approximately a quarter mile from Lake Texana. The landowner reported that runoff from overnight rains had washed an oily residue into the front yard of his home, leaving a visible residue and noxious smell. The Lavaca Navidad River Authority investigated the incident and located the source of the sludge material. Upon further investigation, it was determined that the containment berm had been inadequately built to retain the salt water sludge and rainwater. The sludge had been pumped from the sludge pit onto the ground located around the well, then built a makeshift berm to contain the sludge. The berm located around the sludge began to fail once the containment berm was saturated. Given the local topography, the contaminated runoff eventually made its way into Lake Texana, approximately 800 yards from the well site. The Texas Railroad Commission was notified along with the owner of the well. LNRA made a second visit to the site on Monday December 17, 2018 to ensure proper measures were taken to collect and contain the sludge. The appropriate berm had been built and the land scraped in efforts to collect the sludge that had made its way downhill towards the Lake Texana. Water quality remains positive even after the spill likely due to low pollutant volume introduced into the lake.

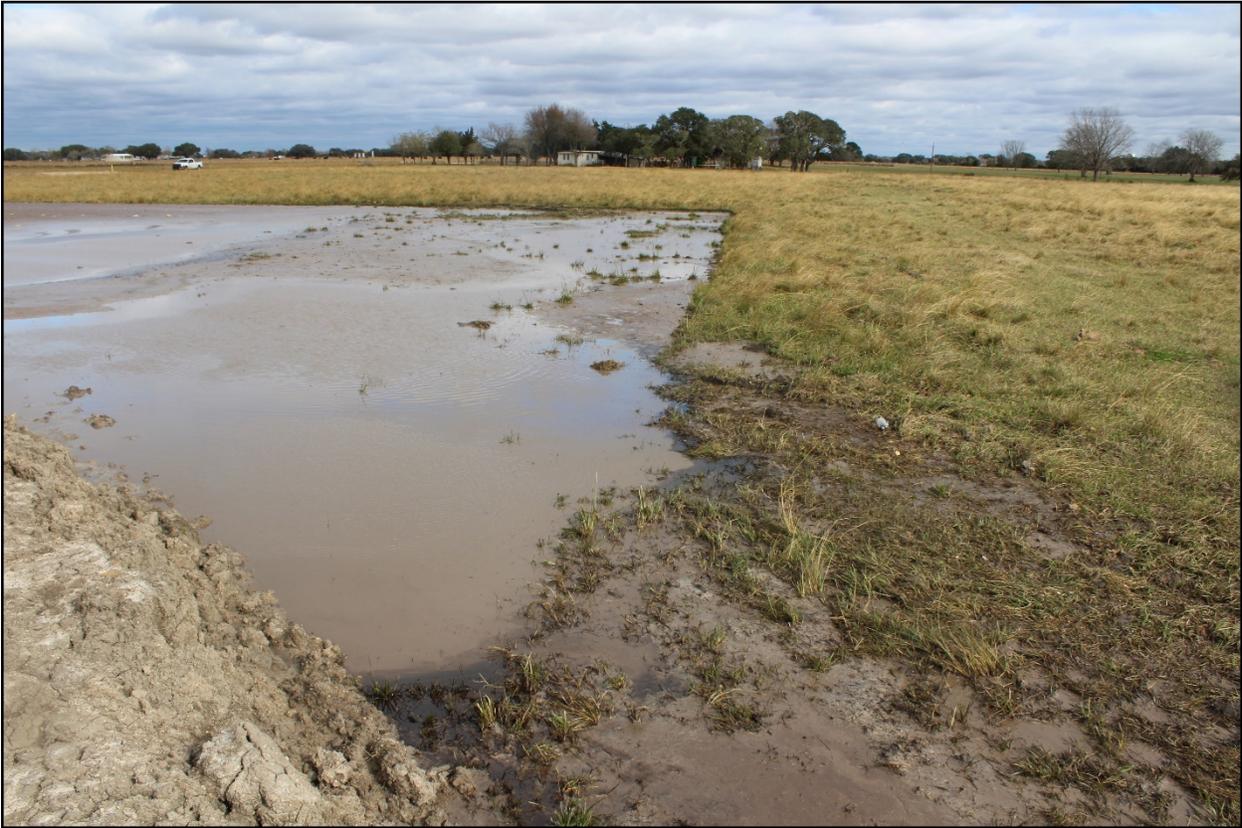
Figure 4: Berm failure at oil field sludge spill site

- The Lavaca-Navidad River Authority responded to one reportable incident this year. Failure of a berm constructed to contain oil field sludge caused the sludge material to enter a nearby water course, carried by runoff caused by heavy rainfall. The incident was located off FM 2982 southwest of the City of Ganado, the incident was contained, and the cleanup of the waste resolved quickly by the performing party.

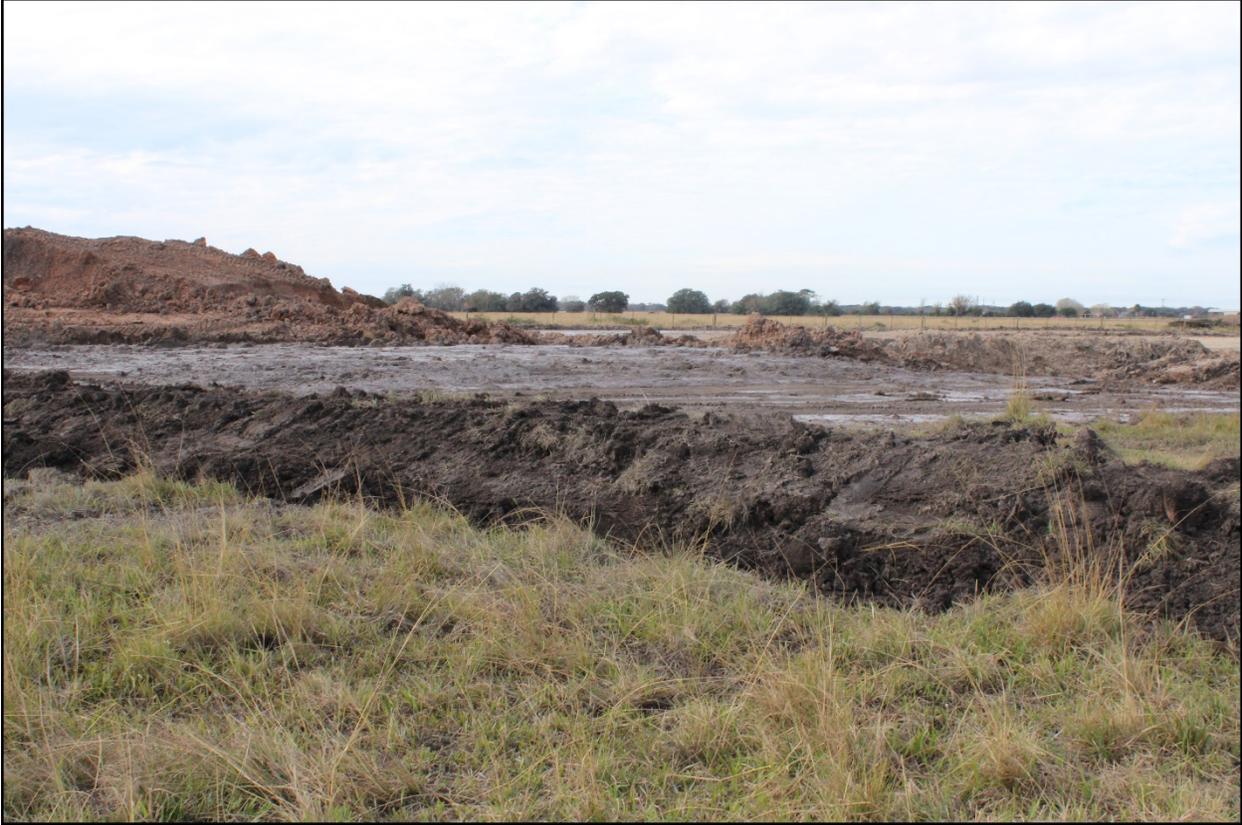
Figure 5: Berm reconstruction at oil field sludge spill site

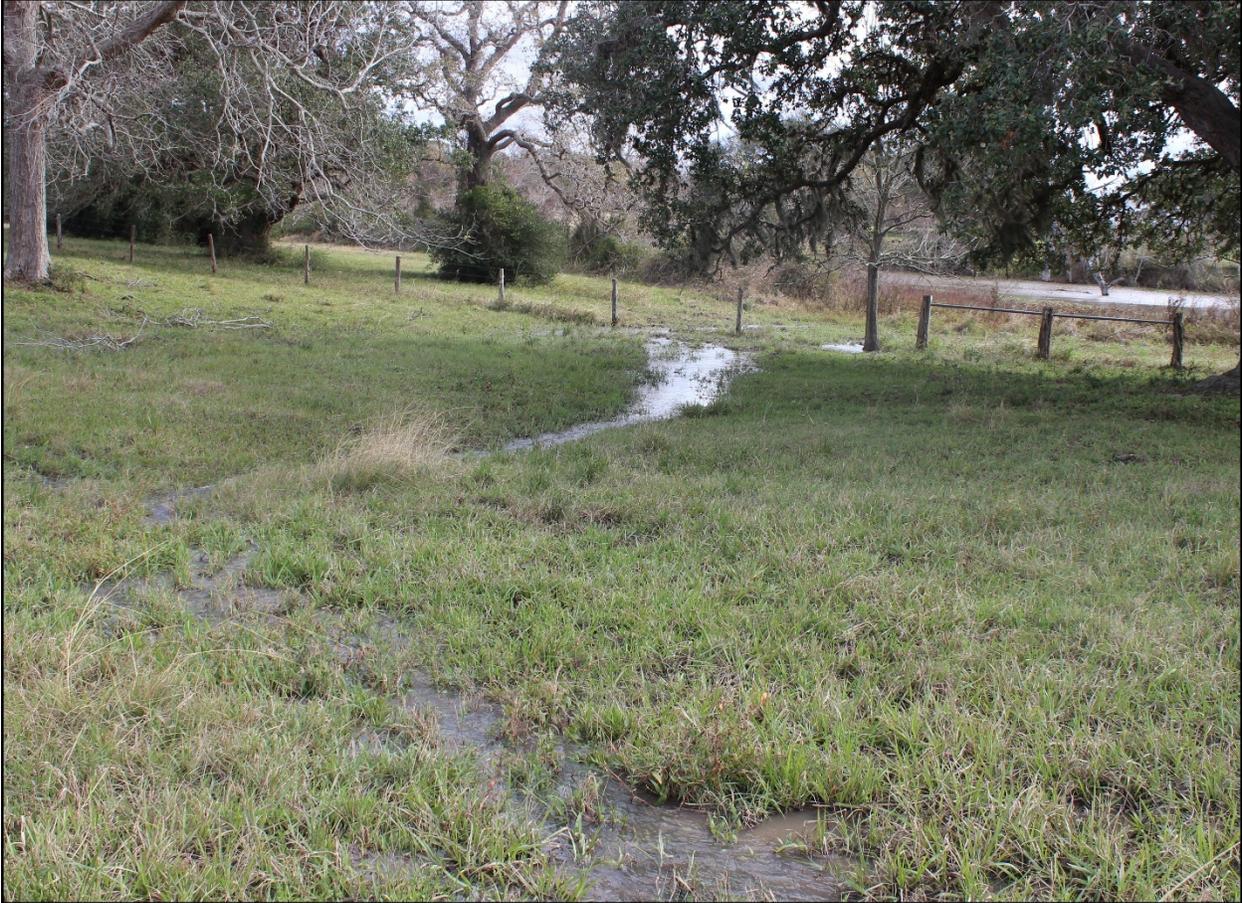
Figure 6: Water flowing into Lake Texana from oil field sludge spill site
