2015 Lavaca Basin Highlights Clean Rivers Program Report

**Prepared by the
Lavaca-Navidad River Authority (LNRA)
PO Box 429, Edna, TX 77957**

LAVACA BASIN HIGHLIGHTS REPORT 2015

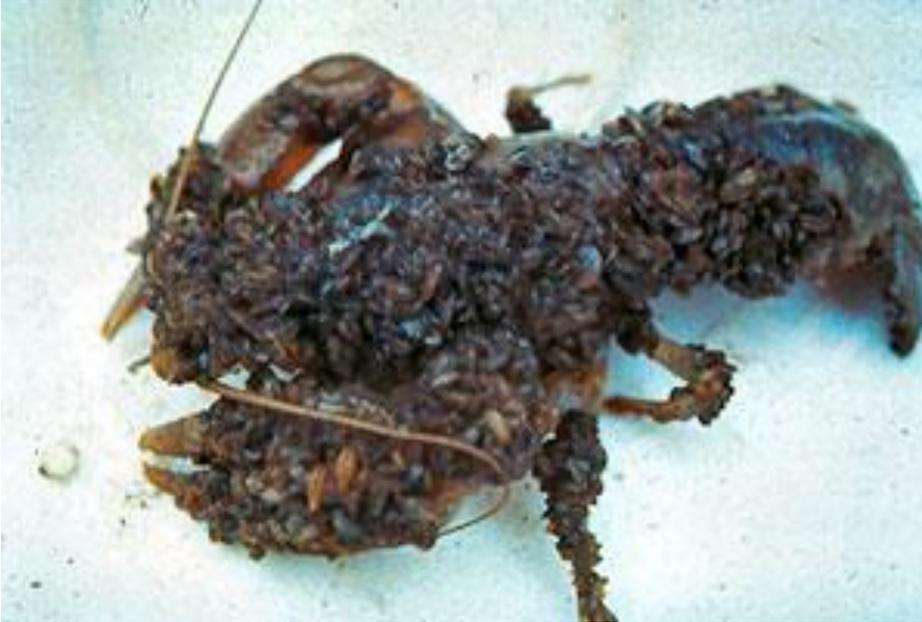
Figure 1 – Invading zebra mussels on crawfish (not from Lake Texana)

Without any known native predators, the main weapon against this invasive parasite is education. Boaters are the number one transporter of the organism. The LNRA has passed out pamphlets explaining zebra mussels and their destructive nature to all known bait stands and boat shops in the vicinity of Lake Texana. In cooperation with TPWD, metal signs with information on how to clean and drain water craft to prevent further infestation have been posted at all boat ramps around the lake (see figure 2). A large stencil was purchased this year by LNRA and painted at the beginning of all boat ramps stating "Stop Zebra Mussels. Clean,

Drain, and Dry your boat, it's the LAW". Personnel from LNRA performed a visual inspection of all boat ramps and found zero evidence of zebra mussels in Lake Texana. More information about zebra mussels in Texas waterways may be found at www.texasinvasives.org/zebramussels.

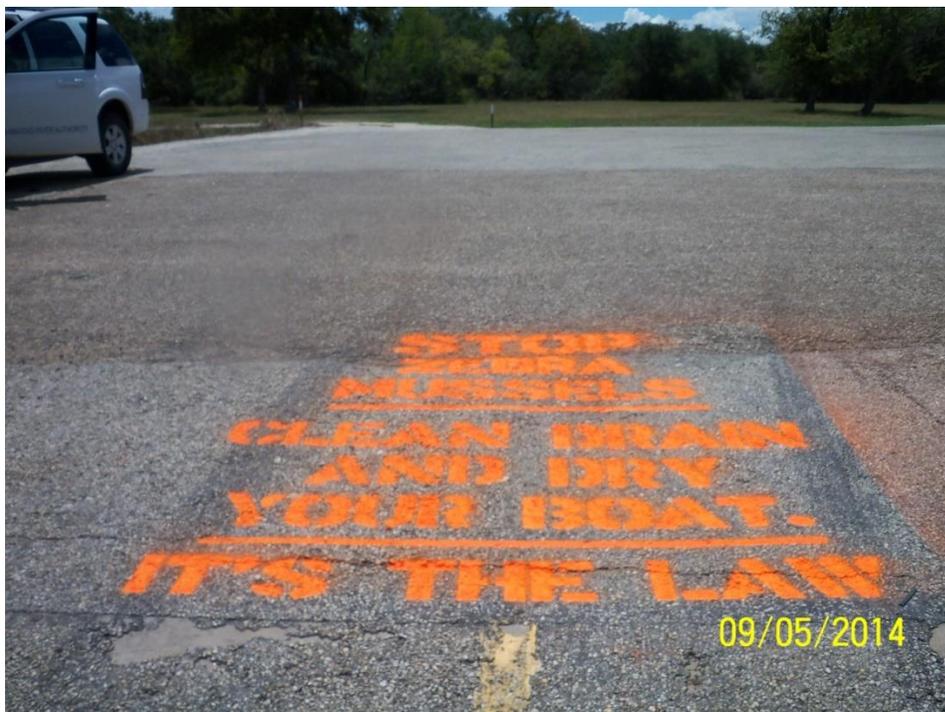
Figure 2 – Zebra mussel/boaters warning stencil work at public boat ramps.

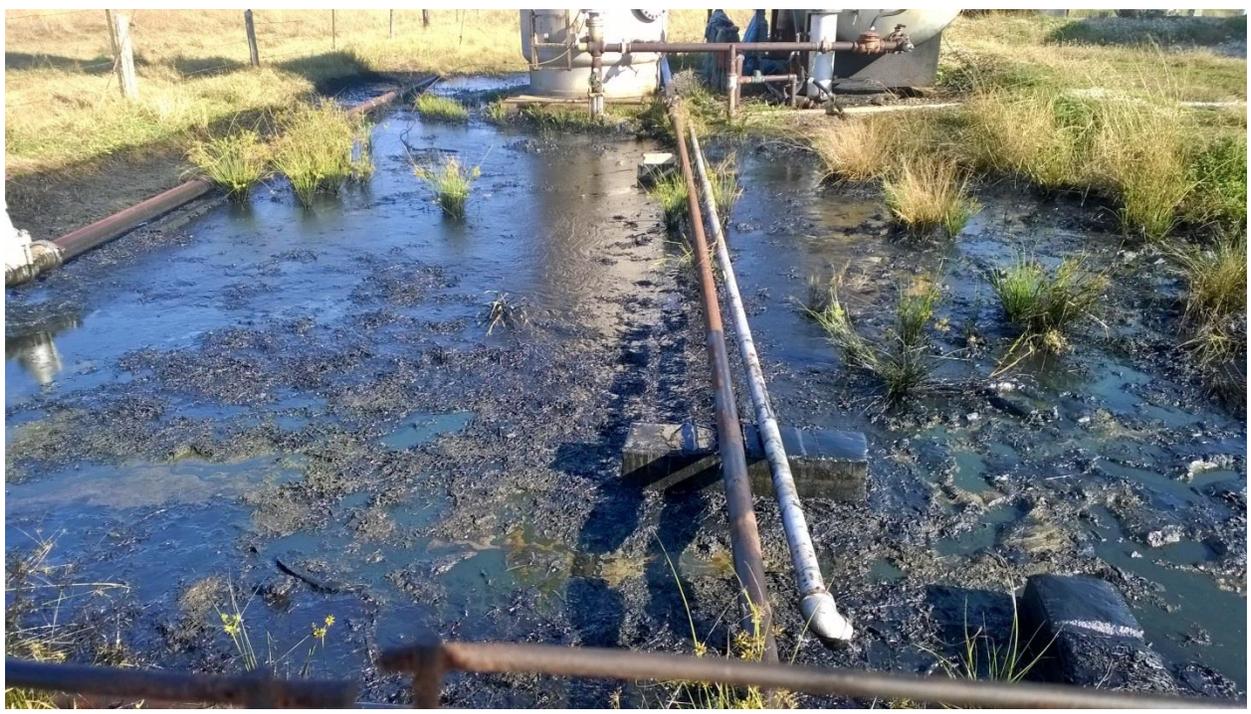
Figure 5 – Oil spill off of FM 2982 out of Ganado

On December 12, 2014 the Authority was contacted by Mr. Roades, a local land owner, about a ruptured oil tank located on his property and in close proximity with Devers Creek, a creek that flows into Lake Texana. The Authority met with the Railroad Commission at the site to assist with containment and recovery of any contaminants. The owner of the lease, Premier Natural Resources, had a knock out tank rupture and release approximately 100 barrels of produce water and 10 barrels of free oil. Liquids breached the firewall and flowed into a pasture and down a ditch that led to Devers Creek, a small tributary of Lake Texana. A temporary berm was constructed across the ditch containing the contaminants to a small area preventing defilement of the lake. A local vacuum truck service picked up and disposed of the liquids.
